HISTORIC PROPERTY INVENTORY FORM

Field Site No. 3713 OAHP No. _____ Date Recorded 7 Oct 1994
Site Name Historic Receiving Storeroom Revised 29 May 1998
Common Carpenter Shop
Field Recorder K.A. Simmons, M.E. Crist, I.C. Lindsay, J.K. Keating
Owner's Name Department of Energy, Richland Operations Office
Address P.O. Box 550
City/State/Zip Code Richland, WA 99352

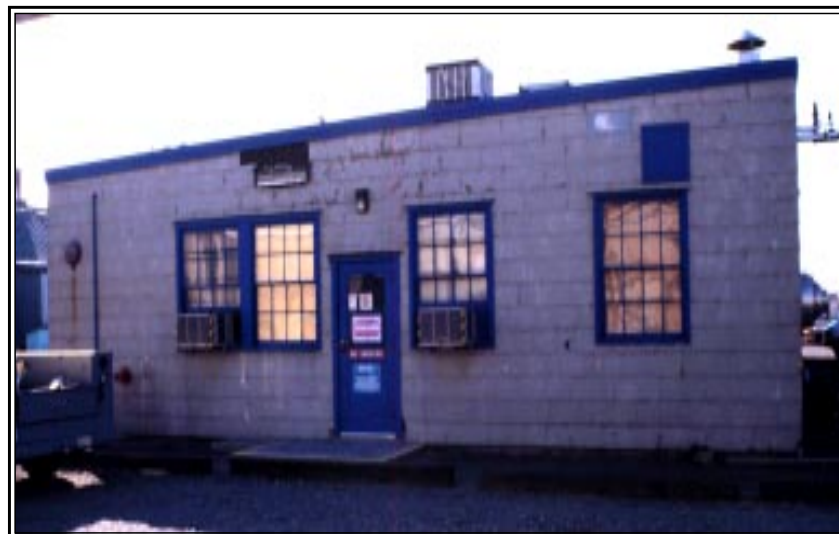
Photo at right; Roll 163, Frame 27
view of north facade

The 3713 Carpenter Shop is a one-story, wood-framed, rectangular building with a shed roof, concrete block walls and a north-south orientation. The dimensions of the structure are 120 feet by 40 feet and covers 4880 square feet. The west wall contains many multi-pane windows, some of which are double-hung and fairly new. On the south wall, there is a single entry door with semi-circular steps leading to it. On the east elevation, there are also many multi-pane windows. Replacement glass and frames have been installed in some windows and a few are boarded up with plywood. On the south end of the elevation is the concrete pad enclosed by a metal fence which blocks the view of a door. The interior of the building contains wooden 2 inch by 6 inch crossbeams visible along the ceiling. Two sets of wood columns run the length of the concrete slab floor. A wall divider is still in place from the days when the building was divided into three parts by presswood partitions. Florescence lighting is present inside the building; it is unknown if the explosion proof incandescent lighting originally in the paint shop still exists. Radioactive contamination is present in the 3713 Building which has stored contaminated salvage materials and tools in the past. The building has been slightly modified since 1980 including the relocation of a door.
